## ADVISORY CIRCULAR 43-16A

# AVIATION MAINTENANCE ALERTS

ALERT  
NUMBER  
296

MARCH  
2003

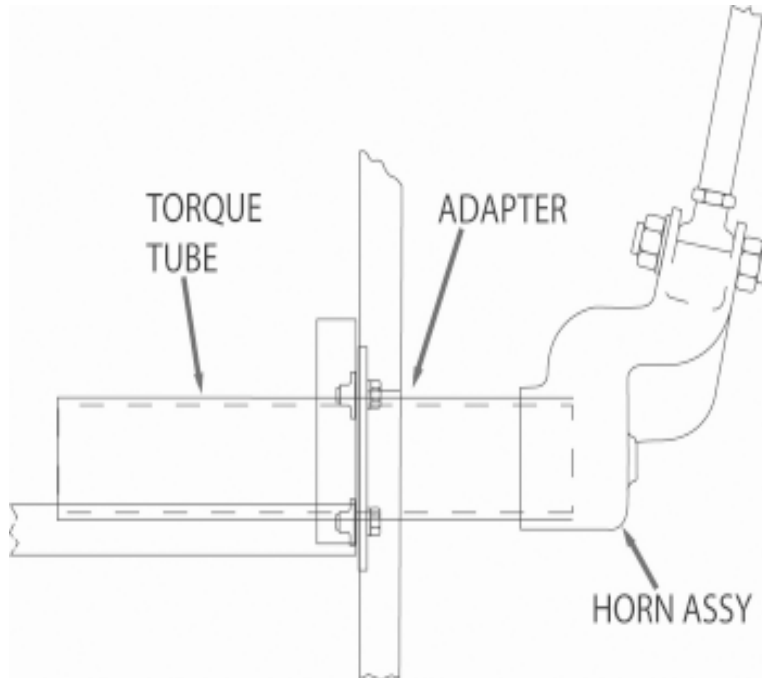
##### **Beech; All Model 1900 Series; Airliner; Elevator Torque Tube Assembly; ATA 2730**

An FAA inspector from the Ft. Lauderdale, Florida, Flight Standards District Office (FSDO) reported the elevator torque tube assembly (P/Ns 101-610019-5 left and 101-610019-6 right) on the Beech 1900 aircraft failed.

Two operators found movement in the area of the torque tube to the tube adapter and in the horn assembly (P/N 101-610019-7). (Refer to the illustration.)

The FAA Service Difficulty Reporting Program data base revealed 17 similar reports for the period of January 1, 1995, to January 28, 2003. According to the reported information, movement in the area of the torque tube to the tube adapter and the horn assembly are caused by loose rivets.

The submitter recommend that all operators of Beech 1900 aircraft conduct routine inspections for movement in the area of the torque tube to the tube adapter and the horn assembly.

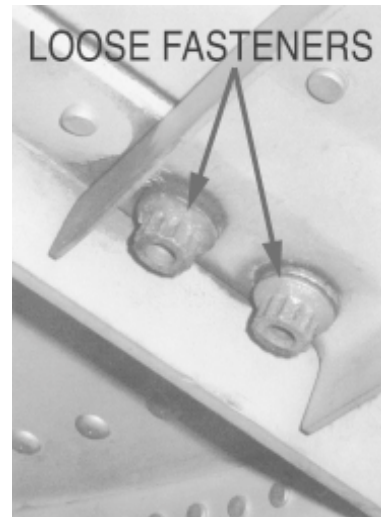
The upper four attach bolts (P/N EWB 22-5-14) for the vertical stabilizer forward spar were loose. All four bolts were below minimum torque specification. (Refer to the illustration.)

The FAA Service Difficulty Reporting Program data base revealed 10 similar reports of loose vertical stabilizer forward spar attach bolts.

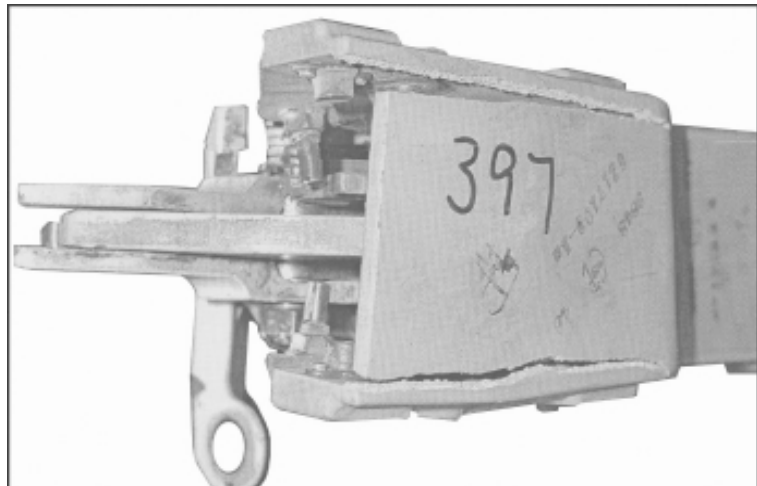
The technician discovered a broken ground wire at pin F of the main landing gear uplock microswitch (P/N H11-1307-1) connector. The broken wire caused the left main gear uplock to close and lock before the landing gear was fully retracted. This action resulted in the uplock housing assembly and uplock mechanism to be smashed by the retracting landing gear. He suspects the wire broke due to age. (Refer to the illustration.)

The submitter recommends that all operators of Cessna 650 Citation aircraft inspect the main and nose landing gear uplock microswitch connectors.

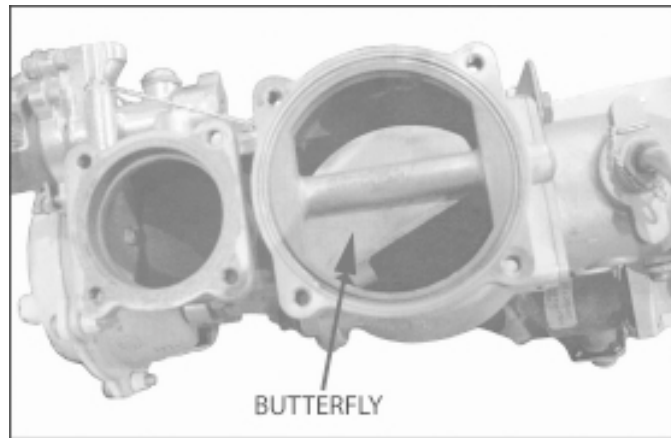
A recently processed Malfunction or Defect Report cited failure of the bleed air shutoff and pressure regulator control valve (P/N 3214478-2).

The submitter stated that the low-pressure butterfly portion of the control valve came apart. An investigation revealed that the hinge pin apparently failed. (Refer to the illustration.)

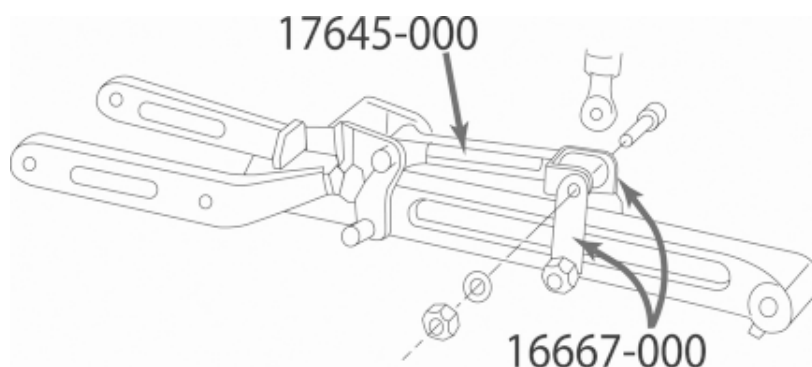
An investigation revealed the hydraulic actuator connector links (P/N 16667-000) broke in half which also ripped open the bolt holes for the nose landing gear locking link (P/N 17645-000).
